SIDE PROTECTION IN 2-DOOR AND 4-DOOR PRODUCTION VEHICLES MDB-TO-CAR SIDE IMPACT TEST OF A 26° CRABBED MOVING DEFORMABLE BARRIER TO A 1981 CHEVROLET CITATION AT 33.5 MPH

J. Stultz

Vehicle Research and Test Center P.O. Box 37 East Liberty, Ohio 43319

Contract No. DTNH22-82-A-08401

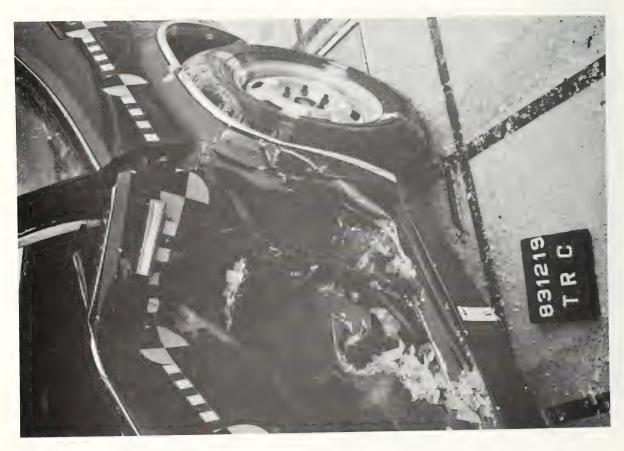
Figure A-21. POST-TEST PASSENGER DUMMY - VIEW 2

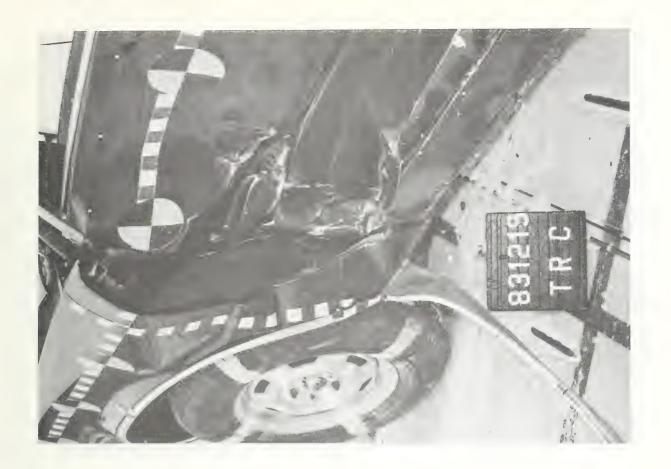
Figure A-22. POST-TEST VEHICLE DAMAGE - VIEW 1
